# Debonding of the acetabular porous coating in hip resurfacing arthroplasty A case report

From Algemeen Ziekenhuis Nikolaas, Sint Niklaas, Belgium

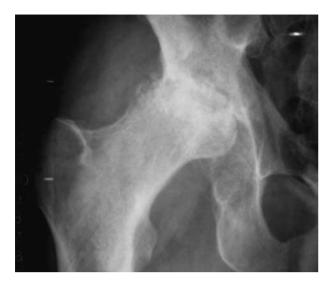
Fig. 1. - Pre-operative radiograph with end-stage arthritis

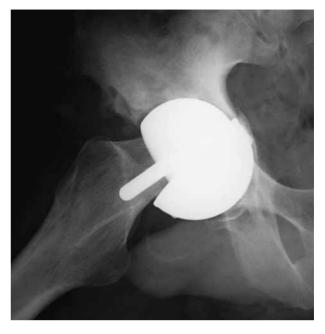
Fig. 3. - Radiograph at failure with marked cup displacement

System. The acetabular cup measured  $56 \times 50$  mm and the outer diameter of the cemented femoral head was 50 mm (ReCap resurfacing femoral head, Biomet). This procedure was performed by the junior author (JDS) as part of a prospective study. The preoperative Harris Hip score was 46. The patient did extremely well. The postoperative Harris Hip score was 95 at 6 months, 99 at 1 year and at 2 years postoperatively. The pre-operative and immediate postoperative radiographs are shown in Figures 1 and 2. Postoperative radiographs made at 6 weeks and 6 months showed excellent component positioning and no radiolucent lines. However, in the beginning of July 2009, 36 months post-operatively, the patient experienced a sudden snap followed by a grinding sensation during heavy work. Radiographs suggested a possible loosening of the acetabular component. The patient returned after 2 weeks with more complaints but without much pain. Further radiographs revealed gross displacement of the acetabular component (Fig. 3). There were no signs indicating infection.

Shortly thereafter the patient underwent a revision arthroplasty of the right hip by the senior author (HD). The acetabular shell was loose and had dislocated. The acetabular component was removed. Part of the titanium porous coating had "debonded" from the back side of the acetabular shell and was extremely well fixed to the pelvic bone (Fig. 4). We had to use curettes to remove the ingrown coating from the acetabular floor. The surrounding area showed signs of metallosis. The acetabulum was re-reamed and a new porous coated shell with screws, two sizes larger than the previously used resurfacing cup (Exceed ABT 15°

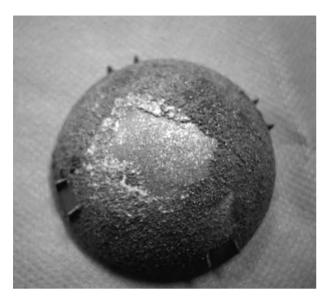
*Fig. 4.* — View of the porous coated cup showing debonding of the plasma spray coating.

Debonding is impossible with the porous coating of the Birmingham Hip Resurfacing (BHR, Smith & Nephew) which is an entire part of the cup. In the ReCap as in many other systems a plasma-sprayed coating is used. This coating proved to be working well in the classic total hip replacement with a stem and a relatively smaller head. If bony ingrowth of the shell to the pelvis is incomplete, shear forces applied to the bony junction are too high and patches of porous coating are sheared from the cup during loading, resulting in failure. Manley et al (2) performed a biomechanical study to evaluate the shear stresses of five different interfaces and found that the shear strength of the coating-substrate interface was similar to or less than that between coating and bone. This might be a possible explanation for this rather new complication.

acetabular shell, porous and HA coated, 60 mm diameter, Biomet), was inserted. The femoral component was well fixed in good position, but had to be removed also because a revision cup with a larger outer diameter and an unchanged inner diameter equipped with offset screws for fixation is not available now. A short porous coated and lateralized stem (Taperloc Microplasty 13.5 mm  $\times$  112.5 mm, Biomet) replaced the femoral component. The acetabular insert (Exceed ABT ceramic Biolox Delta) and the head (Biolox Delta 36 mm – 3 mm neck type 1 taper, Biomet) were ceramic.
