Fracture of the femoral alignment stem of a hip resurfacing arthroplasty A case report

Mohammed A. BHUTTA, Vinod B. SHAH

From East Lancashire Hospitals NHS Trust, Blackburn, United Kingdom

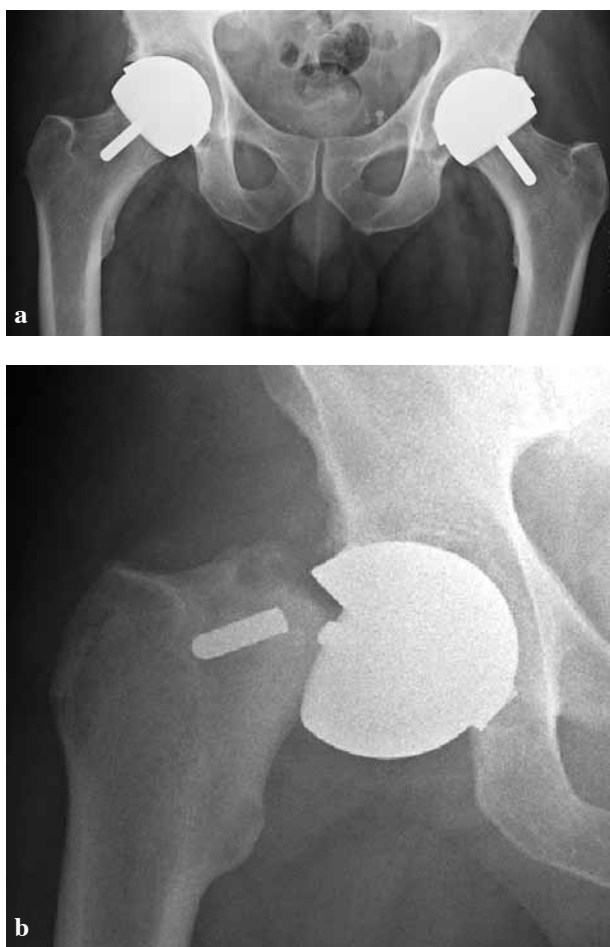
A 58-year-old medically fit male with bilateral hip osteoarthritis underwent staged HRA starting with the right hip. This was performed under spinal anaesthesia in the lateral position using the standard posterior approach. The acetabulum was reamed to 60 mm and a 62 mm cup was inserted with a press fit. The femoral head was reamed with no evidence of any cystic lesion or notching of the femoral neck. A 56 mm femoral head was cemented while the stem remained uncemented. The patient made an uneventful recovery and at 6 months was asymptomatic with a complete range of movement and so proceeded to HRA on the left. The post-operative course again was unremarkable (Fig. 1a).

Fig. 1. — a) AP Pelvis radiograph. Demonstrating femoral stem in neutral alignment (lateral view not shown also confirms neutral alignment), b) Radiograph of femoral alignment stem fracture.

Twenty four months after the right HRA, the patient described a twisting episode with acute onset of groin pain and an inability to bear weight. Plain radiographs confirmed a fracture of the right femoral neck and stem of the femoral resurfacing component (Fig. 1b). The patient denied any hip/groin pain prior to this or of any precipitating traumatic event.

He underwent revision arthroplasty by the original surgeon (VBS) seven days later. Intra-operatively, no gross cysts or macroscopic signs of avascular necrosis were visible at the fracture site ; there was no evidence of infection ; all cultures and tissue

samples sent for microbiology were negative. It was noted intra-operatively that the fracture extended beneath the superior rim of the femoral component. The distal femoral stem was well fixed within the femoral neck and was centrally located ; it could be removed only after the femoral neck cut. The femoral resurfacing component was replaced with a Biometric (Biomet, Warsaw, USA) uncemented femoral stem and a Magnum 56 mm metal femoral head. The patient made a complete recovery and at the two year follow-up remains asymptomatic with a full range of movement.

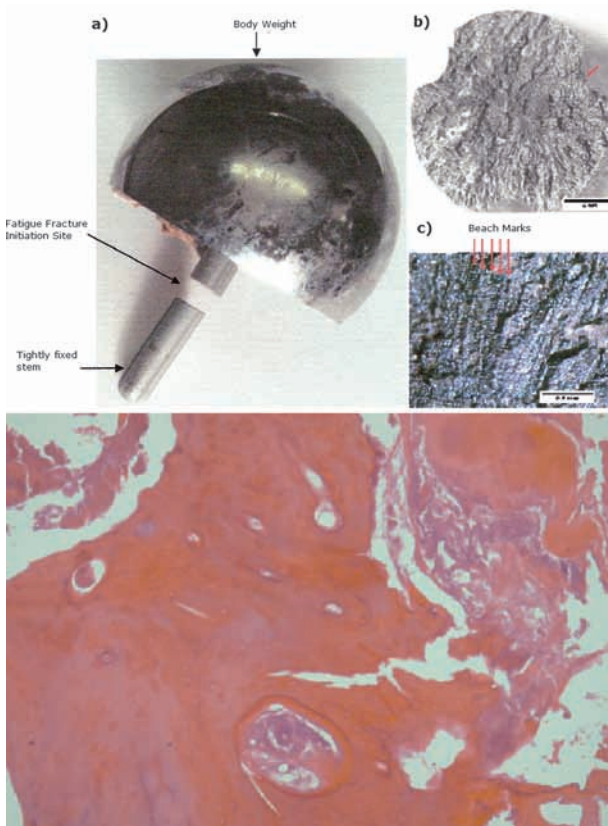
The retrieved femoral component was analysed by the manufacturer who confirmed the component met the specifications of manufacture with no defects of the material. Analysis of the fracture surface further suggested that the stem failed under fatigue loading with evidence of progression 'beach' marks inferring crack initiation from a flute on the stem, indicating cyclic bending forces from a more rigidly fixed distal stem compared to the rest of the stem and femoral head (Fig. 2a-c).

Fig. 2. — a) Possible forces causing fatigue failure of femoral stem, stereomicroscope composite images with b) inferred crack initiation point (red arrow), and c) close up image of beach marks (red arrows), d) histological view of subcapital bone fragments.

The histological analysis of the bone tissue is complicated by the delay to revision surgery, such that bone could appear degenerate from either fracture or AVN (Fig. 2b). However, the lack of reparative fibrous and granulation tissue and loss of osteocyte nuclei from lacunae in cancellous bone and formation of appositional new bone may suggest that AVN was not the primary diagnosis and may represent bone resorption (5). Nevertheless, a gradual process of load transfer to the alignment stem induced local bone changes around the distal stem fragment for it to become well fixed distally without cement.

Our case describes the first report of a fracture of the femoral alignment stem in a ReCap (Biomet Inc.), neutrally aligned femoral component two years from the initial procedure. This may represent an argument to improve the load tolerance of the alignment stem and possibly removing flutes to support the femoral component while bone adaptation occurs possibly preventing a delayed femoral neck fracture. This complication may increase in frequency as the use of the technique expands.
