## A groin mass caused by metal particle debris after hip resurfacing

**We present the case of a benign groin mass associated with metal particle debris after hip resurfacing. We discuss the histological diagnosis of 'aseptic lymphocytic vasculitis associated lesions' (ALVAL).**

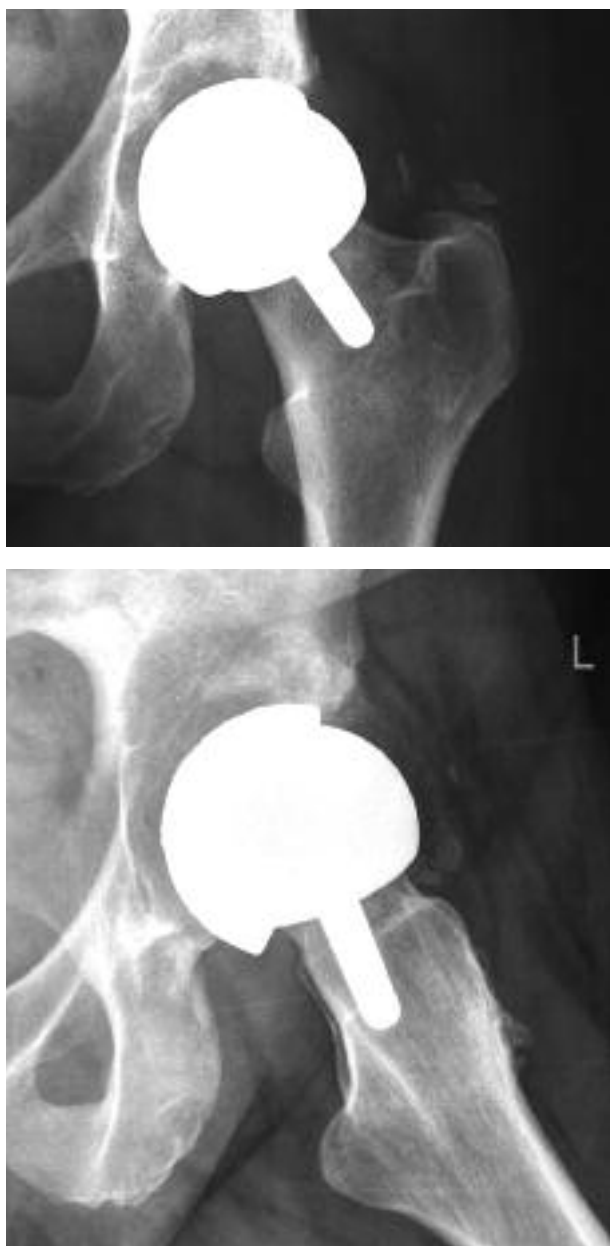
*Fig. 1.* — Radiographs of the hip (AP and Lateral)

Plain radiographs revealed a vertical cup with more than 60 degrees of abduction. There was no evidence of prosthetic loosening (fig 1).

The acetabular component in this case was seated in a very vertical position with an abduction

angle of more than 60 degrees. An abduction angle of less than 55 degrees is recommended (2,15,17,22), with many surgeons preferring approximately 40 degrees. The cup position in this patient may have resulted in excessive wear and higher blood metal ion concentration triggering the immunological reaction, ALVAL.

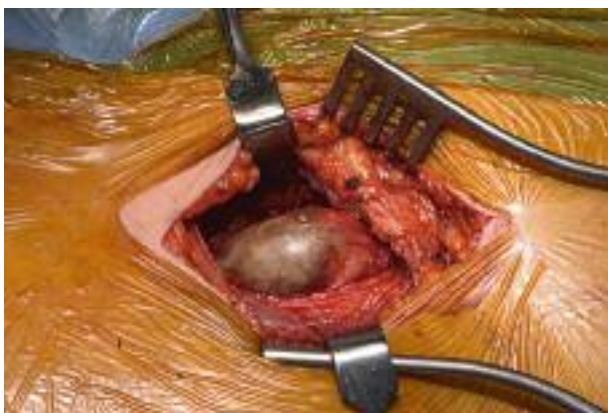
**Fig. 2.** — Exploration of groin lump prior to opening capsule

Exploration of the groin lump revealed an encapsulated, grey-brown lump lying lateral and deep to the femoral vessels. It was approximately  $3 \times 3$  cm in size and extended deeply towards the joint capsule (fig 2).

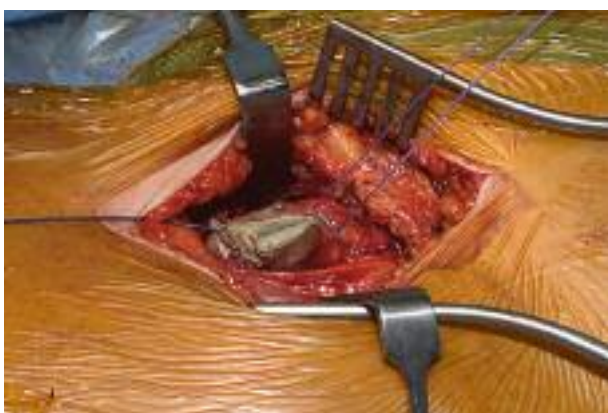
**Fig. 3.** — Following the capsule being opened

The capsule of the lesion was opened (fig 3). This revealed a thick, grey, paste-like substance (fig 4). The paste was removed, the capsule of the lesion debrided, and the wound was closed.

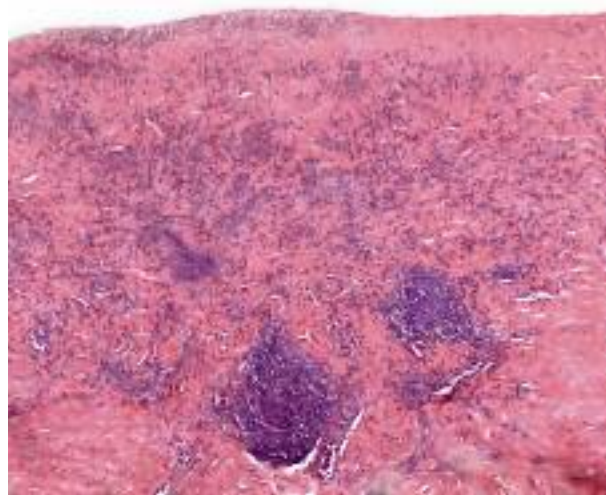
Microbiological examination of the paste revealed no organisms on standard culture, but did identify a coagulase negative staphylococcus on enrichment. Histological examination was in keeping with the recently described 'aseptic lymphocytic vasculitis associated lesions' (ALVAL) (fig 5).

**Fig. 5.** — Histology. The top surface is synovium which is generally necrotic. Lymphocyte aggregates are found in the deeper layers.

The mass described in this case tracked anteriorly to the femoral vessels from the hip joint. With histological evidence of ALVAL, metallic particle debris from the hip resurfacing seems to be the obvious cause.
