## Unusual mode of mechanical failure of an AO cannulated self drilling screw. A case report

*From Queen Margaret Hospital, Dunfermline, Fife, United Kingdom*

**Keywords:** unravelling of threads ; cannulated screw failure.

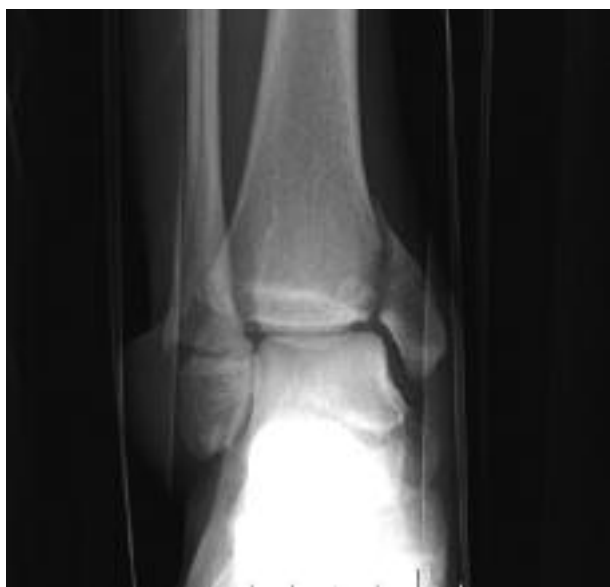
A 14-year-old Caucasian female patient was admitted after injuring her right ankle while playing on a trampoline. She sustained a supination-adduction injury with a vertical fracture of the medial malleolus and a Salter Harris type II injury to the lateral malleolus (fig 1).

*Fig. 1.* — Supination- adduction injury of the right ankle

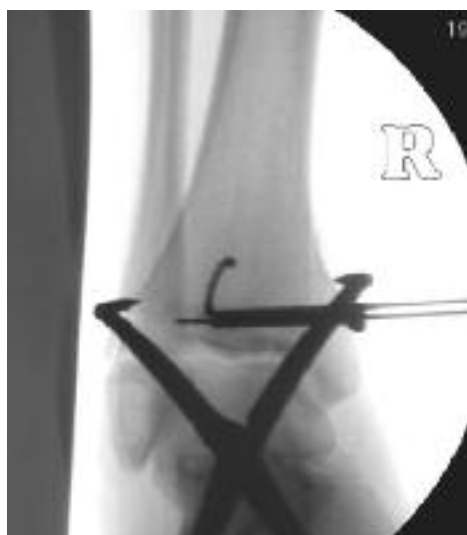
A 40 mm long 4.5 mm cannulated cancellous self drilling screw was inserted over the guide wire and was tightened by hand. During this, unusual resistance was felt while the screw was halfway in. Fluoroscopy revealed an unusual picture -unwinding of threads of the screw with the threaded region migrating perpendicular to the line of the screw

*Fig. 2.* — Screw threads unwinding

fixation. The fracture was fixed with another screw before attempting removal of the affected screw (fig 2).

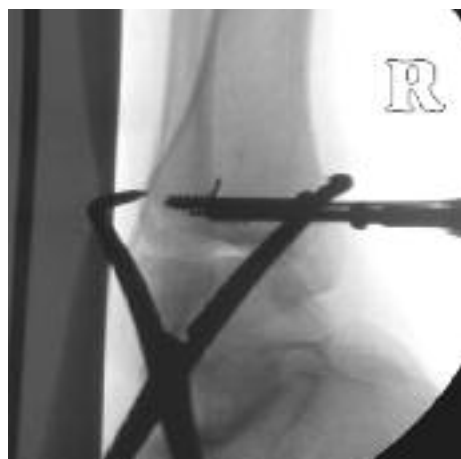
As the screw was withdrawn gently, the threads were seen to be winding again over the guide wire and the screw was removed without any difficulty (fig 3 & 4). The fracture was fixed with one more screw in a satisfactory position (fig 5).

*Fig. 3.* — As the screw is withdrawn, the threads are seen winding again on the guide wire.

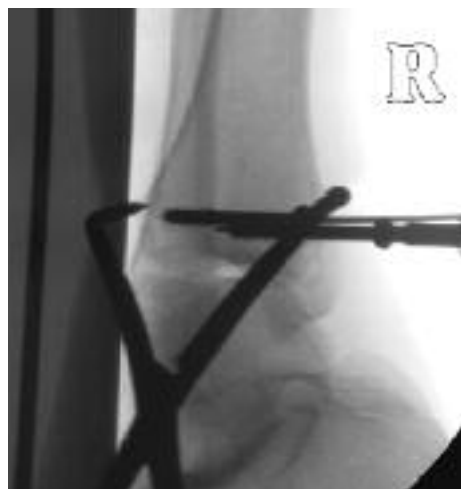
*Fig. 4.* — As the screw is withdrawn further, the threads are fully wound back.

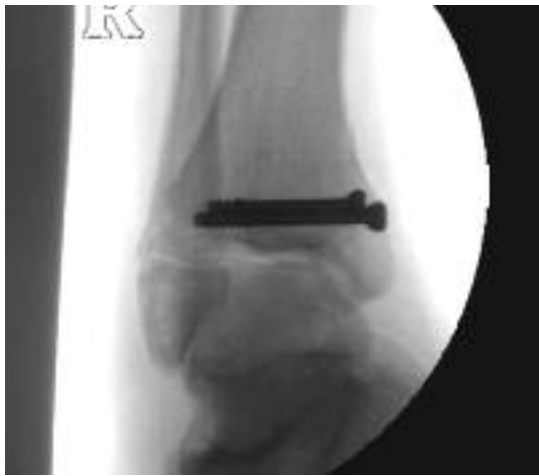
*Fig. 5.* — Final fixation with an additional screw, no part of the previous screw left inside.

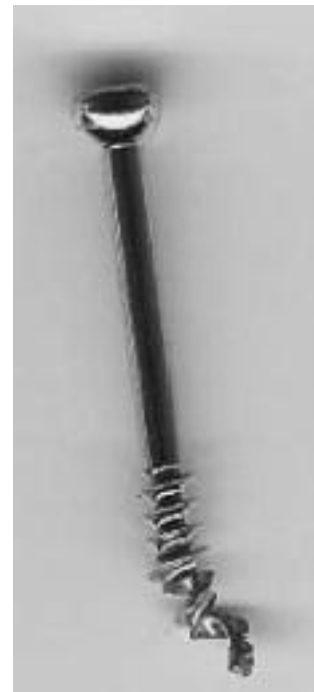
The removed screw showed a continuous split along the root diameter in a spiral manner corresponding to the troughs of the threaded region (fig 6).

The difference between shaft diameter and root diameter is less in a cannulated screw compared to a non cannulated one. This means that a cannulated screw has less tensile strength compared to a solid screw (1). The area of troughs in the threads forms a weak spot where a crack may propagate in a spiral manner through the screw shaft, leading to unwinding of the threads. In the case presented, this did not occur with the other two screws which were of similar configuration used to fix the same fracture in the same patient using the same technique. The senior authors (IW, IJB & DC) also do not recollect

*Fig. 6.* — The removed screw shows unravelling – threaded area split at the troughs in a spiral configuration.

We agree with authors of previous case reports that the pointed self drilling threads bind or get caught on with the dense bone, leading to a crack propagation through the weakest part, i.e. the troughs in the threads where the mechanical strength of the screw is lowest. The crack initiation might occur when the threads are passing through the cortical bone; the crack would then propagate in a spiral manner as the screw passes through dense cancellous bone, leading to unwinding of threads. This obviously puts a question mark on use of self drilling cannulated screws in periarticular fracture fixation and needs further investigations. We propose that extra care should be practiced while inserting these screws, with frequent use of the image intensifier focusing mainly on the advancing screw end, but the only way to avoid this complication is pre-drilling of bone, especially in teenagers, before screw insertion. We were able to withdraw the screw intact since the unwinding was

Cannulated self drilling cancellous screws are an important constituent of an orthopaedic surgeon's armamentarium. Commonly known complications of these implants usually relate to the instrumentation or to screw breakage during removal. Structural failure in this peculiar way is mostly unknown but is a possible complication. Extra care should be practiced while putting self drilling screws in with additional fluoroscopy control if unusual resistance is felt. Pre-drilling the bone can be another option, especially in teenagers, prior to screw insertion.
