Mechanism of loosening of the Souter-Strathclyde total elbow replacement Evidence from revision surgery

Elaine ROBINSON, Neil BURKE, Paula DOUGLAS, John ORR, Joseph POOLEY

From Queen Elizabeth Hospital, Gateshead, and Queen's University of Belfast, Belfast, Northern Ireland, U.K.

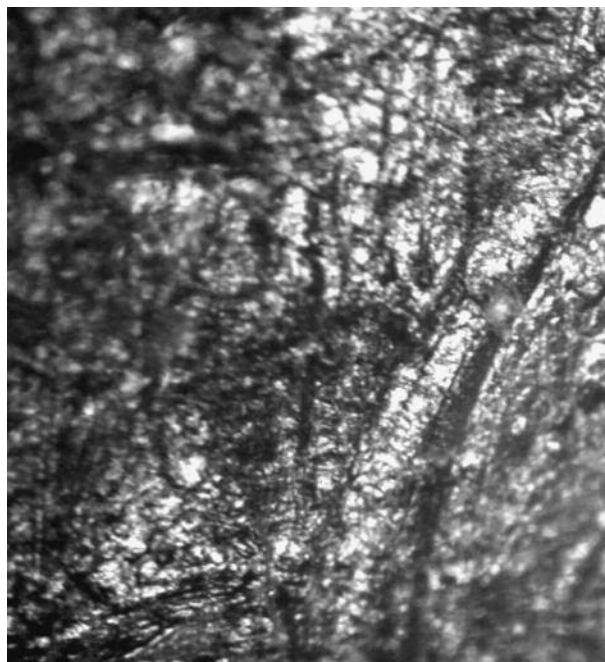
Fig. 1. — Disruption of machining lines on medial and lateral articular surfaces.

Inspection of the retrieved humeral components revealed no evidence of surface wear – the articular surfaces had retained a smooth, highly polished appearance. However examination of the polyethylene ulnar components revealed clear evidence of surface wear in a particular distribution. Only the medial and lateral articulating surfaces were affected. Microscopic wear was exhibited as disruption of the polyethylene machining lines on the medial and lateral articular surfaces (fig 1), with preservation of the lines on the central gliding ridge (fig 2). The wear pattern was macroscopic in five of the nine components with one ulnar component exhibiting a deep linear groove (fig 3) and another a full thickness defect (fig 4).

We believe this resistance results in rocking of the humeral component during flexion and extension and believe this best explains our observed patterns of wear. The central gliding ridge is preserved because the humeral component is not always in contact with it as it rocks out of its articulation in the coronal plane. Furthermore as the humeral component rocks, the sharp edge of its articulating surface makes contact with the articulating surface of the ulna causing abrasion and in the extreme circumstance the deep linear grooves observed above (fig 3). The particulate polyethylene debris liberated by this activity then incites the cellular response, which results in component loosening.

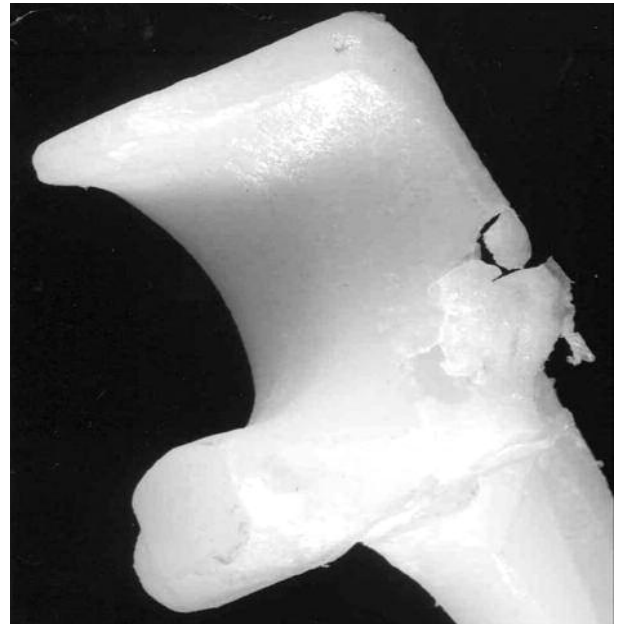
Fig. 4. — Full thickness defect in one of the ulnar components
