## Fatigue fracture of the femoral component in a mobile bearing knee prosthesis

*From the University Hospital, Liège, Belgium*

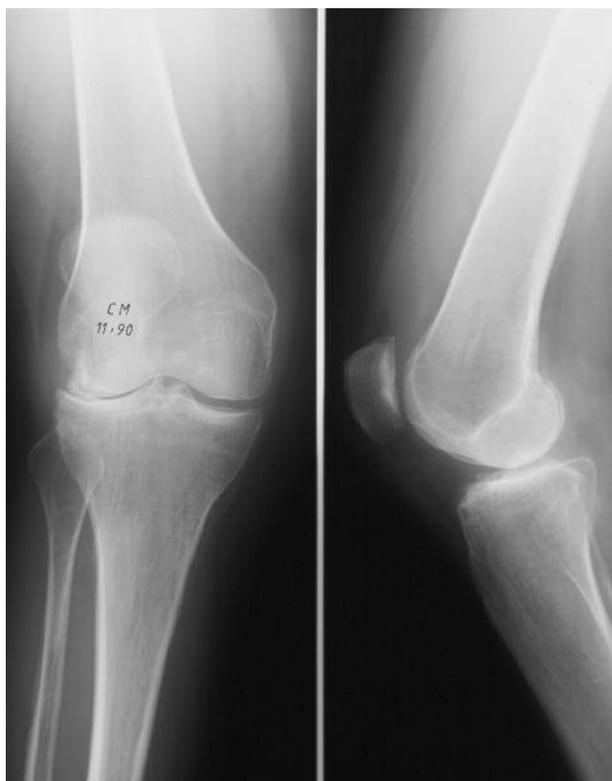
**Fig. 1.** — Preoperative radiographs (AP & lateral) of the right knee, showing severe destruction of the articular cartilage in the lateral compartment, with a valgus deformity. The HKA angle on full-leg standing film was 12° in valgus.

A 58-year-old female patient with moderate valgus deformity of both knees and severe osteoarthritis mostly affecting the lateral femoro-tibial compartment of her right knee (fig 1) underwent total arthroplasty on her right knee in November 1990. A posterior cruciate ligament preserving meniscal bearing New Jersey Low Contact Stress prosthesis (DePuy, Warsaw, IND, USA) was implanted with standard plus cementless femoral and tibial components, and a cementless mobile bearing patellar prosthesis (fig 2). She had a satisfactory clinical result, with a pain free knee and a range of motion from full extension to 105° flexion. She had regular clinical and radiological follow-up at 3 months, 6 months and 12 months after surgery, then at one-year intervals, without any change in her clinical and radiological result. The only

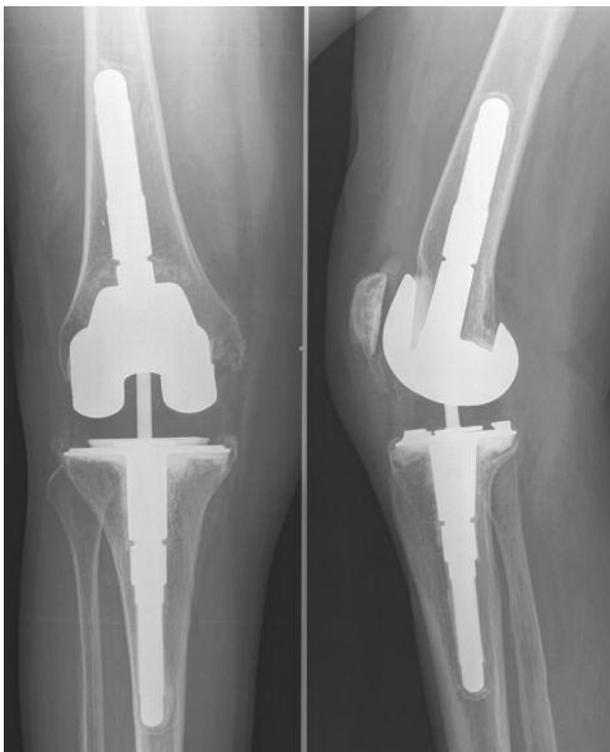
**Fig. 5.** — AP and lateral radiographs after revision with an Insall-Burstein constrained condylar prosthesis with femoral and tibial stem augmentation and a 5 mm distal femoral augmentation.

A posterior stabilized Insall-Burstein constrained condylar knee (Zimmer, Warsaw, IND, USA) with femoral and tibial stem augmentation and a 5 mm

medial femoral distal augmentation was implanted with all components cemented ; bone grafts were not used. The original uncemented mobile-bearing patellar component was exchanged for a cemented dome-shaped polyethylene implant.

When last reviewed 19 years after the index operation and 12 years after the revision operation on her right knee, she reported no pain in either knee, the range of motion of the right knee was 0 to 110°, and 0° to 115° for the left knee. The patient reported no limitation in her daily activities and, although rather sedentary, she reportedly could walk on unlimited distances without external support. Radiographs showed no signs of polyethylene wear, osteolysis or loosening (fig 4).
