Osteochondral defect in femoral head : Trufit ® implantation under fluoroscopic and arthroscopic control

Bart VUNDELINCKX, Kris DE MULDER, Jo DE SCHEPPER

From the Algemeen Ziekenhuis Nikolaas, Sint-Niklaas, Belgium

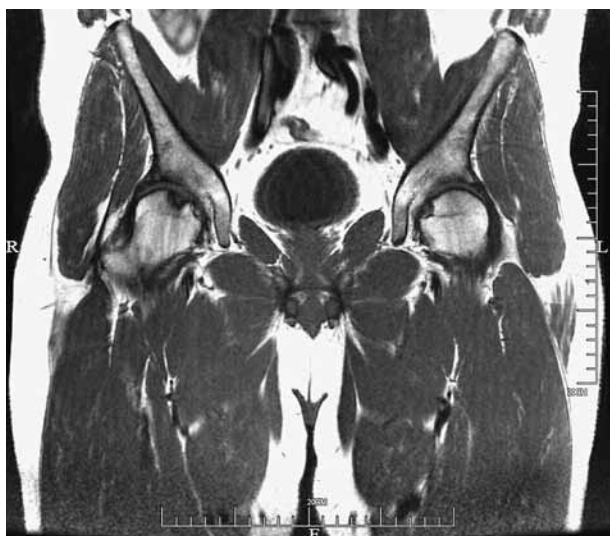
Fig. 1a. — Pre-operative MRI of the pelvis, coronal view. Osteochondral lesion of the right femoral head clearly visible as a defect on the articular side.

Magnetic resonance imaging (MRI) of the hip showed a severe osteochondral lesion with a subchondral cyst on the femoral head (Fig. 1a & b).

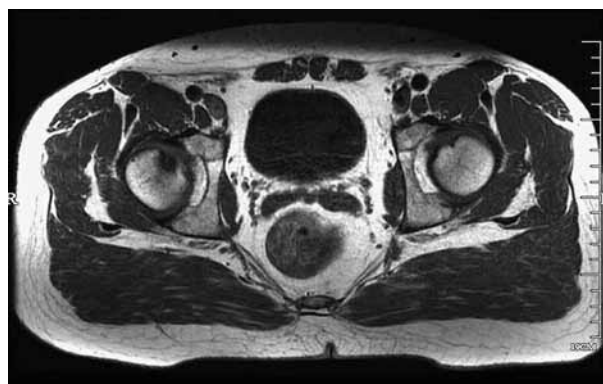
Fig. 1b. — Pre-operative MRI of the pelvis, axial view. Osteochondral lesion of the right femoral head clearly visible as a defect on the articular side.

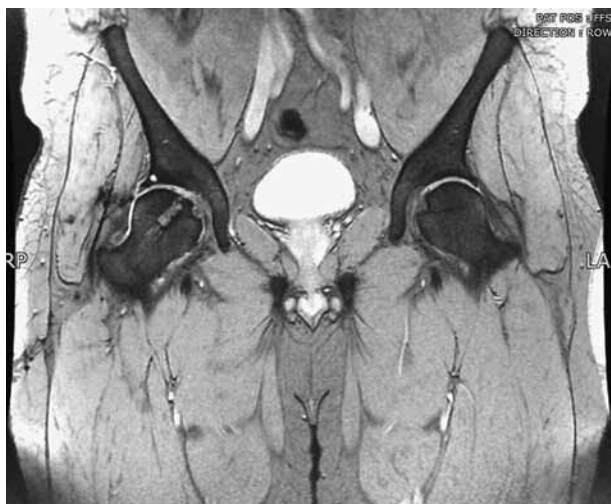
Fig. 2a. — Post-operative MRI at 6 months, coronal view. The Trufit ® Plug is visible *in situ*.

MRI scanning at 6 months showed the Trufit plug *in situ*, without subsidence. But there still is an irregularity on the border of the articular cartilage surface. The big void of the original subchondral

cyst was filled well by the plug. On the border however, a little spot of different intensity persisted (Fig. 2a & b). It is known to be very difficult to interpret those early MRI images of ingrowth of Trufit plugs (2).

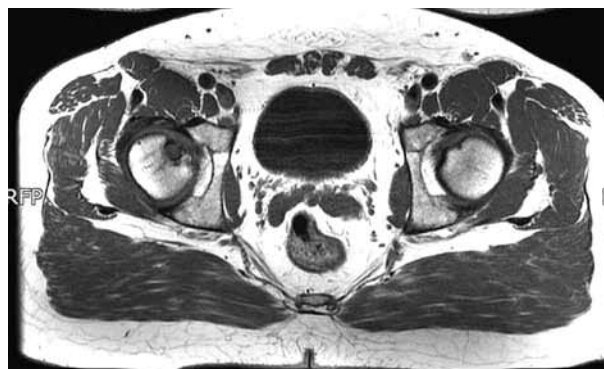
Fig. 2b. — Post-operative MRI at 6 months, axial view. The Trufit ® Plug is visible *in situ*.
