## A rare case of liner dissociation with ceramic-on-ceramic preassembled acetabular components: a case report

In this report we describe a case of LD following THA with a preassembled large femoral head CoC cup design.

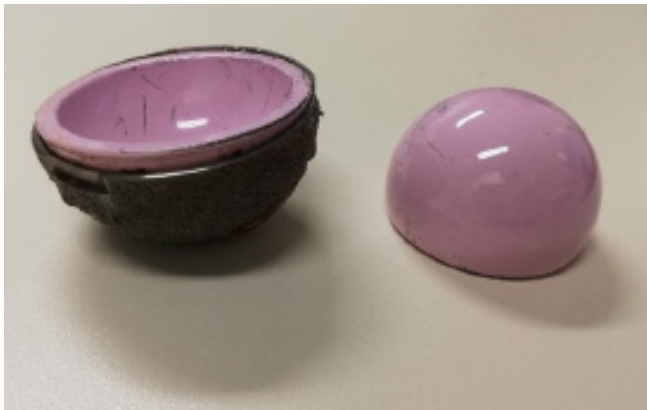
Figure 2. — Removed cup showing slight dissociation of the ceramic liner.

The patient received revision surgery six weeks following the LD. The removed cup showed a slight dissociation of the ceramic liner (Fig. 2). Because of minimal bone damage of the acetabulum after removal of the cup, a 2 mm larger AneXys multi hole revision cup (Mathys, Bettlach, Switzerland) was implanted with screw fixation, polyethylene insert and a ceramic

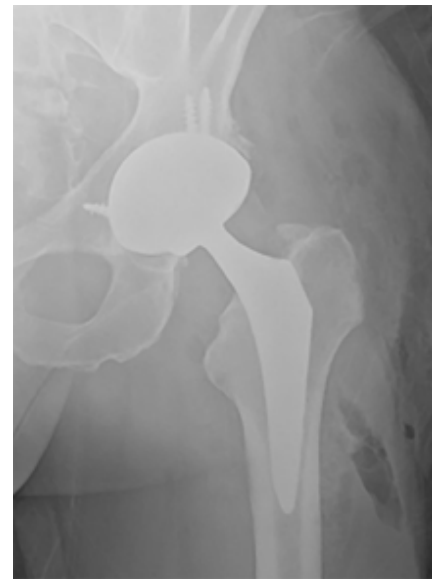
Figure 3. — Post-revision AP radiograph of the left hip showing the correct placement of the revision cup with screw fixation.

revision head (Zimmer Biomet, Warsaw, IN, USA) (Fig. 3). The postoperative recovery and rehabilitation were uneventful.
