Recurrent implant fractures in total hip arthroplasty: a yes-you-yan case report

J. JELSMA, M. ACHARYA

Department of Orthopedics and Traumatology, Southmead Hospital, North Bristol Trust, Bristol, United Kingdom.

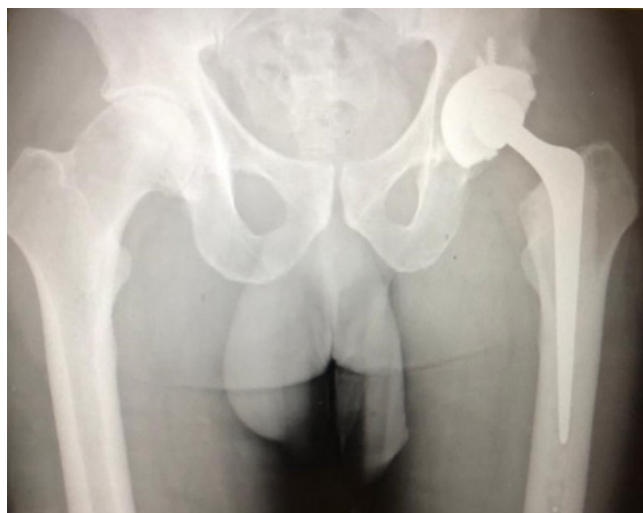
Figure 1. — Primary THR with a cemented Exeter-stem (2001).

A 73 year old male attended our Accident and Emergency (A&E) department early in 2022. His medical history noted a left primary THR for osteoarthritis in 2001. An Exeter stem (Stryker, Kalamazoo, Michigan, United States of America) and uncemented Exceed ABT cup (Zimmer Biomet, Warsaw, Indiana, United States of America) with two screws and a ceramic on polyethylene bearing were used (Figure 1). For the next 14 years he was very satisfied with his hip replacement.

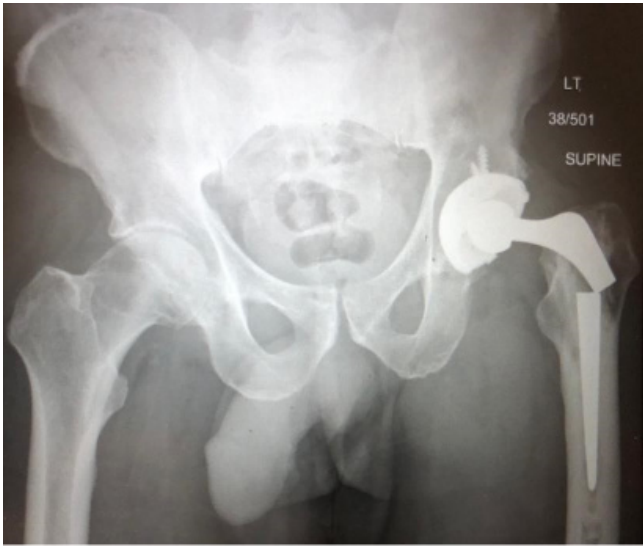
Figure 2. — Implant failure of the cemented Exeter-stem (2015).

By the end of 2015 he started to experience some left hip and thigh pain, which subsequently evolved in an acute setting when an implant fracture of the stem occurred (Figure 2). During surgery a defect anterior in the proximal femur and a fracture of the calcar were found. After removal of the proximal part of the stem and proximal cement mantle intramedullary core reamers were used to explant the distal part of the stem. Unfortunately this was unsuccessful after multiple attempts. Three protective Dall Miles cables

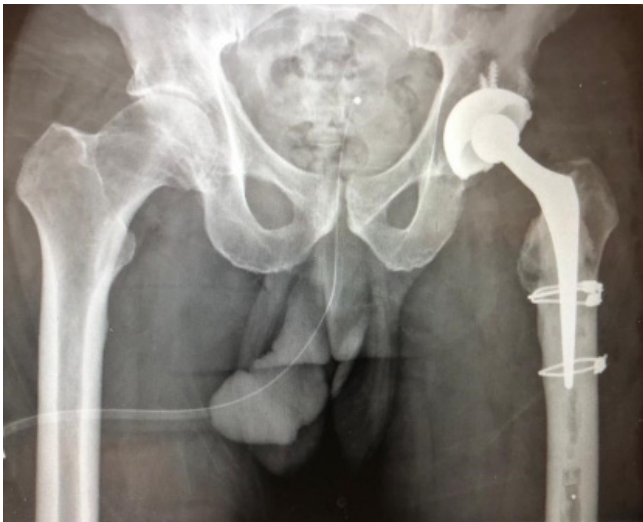
Figure 3. — Anteroposterior view after the first stem revision using a cemented C-stem and three protective Dall Miles cables (2015).

were placed. A small femoral window was created to knock the stem out from distal to proximal and the core reamers were used for the distal cement plug. For reimplantation the cemented C-Stem AMT High Offset Size 1 (DePuy, Synthes, Johnson & Johnson, Raynham, Massachusetts, United States of America) was chosen with a ceramic femoral head 28mm +8.5mm neck (Figure 3 & 4).

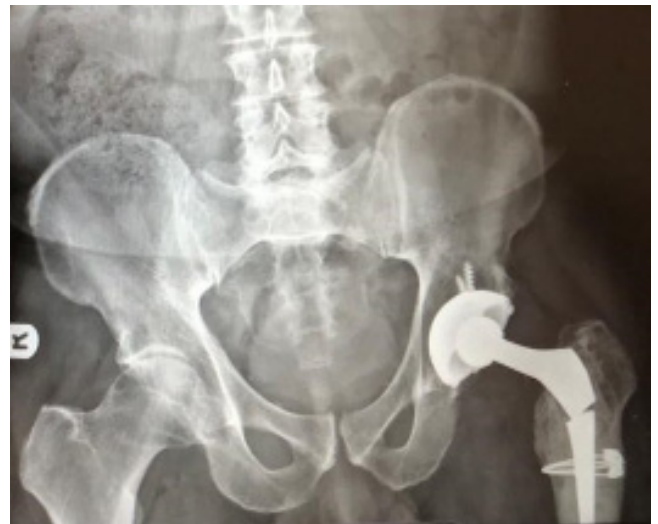
Figure 5. — Implant failure of the cemented C-stem (2022).

returning to his car he was unable to weightbear and knew there was something wrong. He was diagnosed with a recurrent implant fracture of his left THR (Figure 5).

We performed a posterolateral approach for the 3th time. The acetabular cup showed a good position and the polyethyelene did not show any signs of wear. The proximal end of the cement mantle and the proximal part of the stem were removed without any problems. The distal part of the stem was removed with the use of the ultra-burr pencil, osteotomes, curettes and intramedullary core reamers. This was complicated by a small false route on the anterolateral side of the femur at height of the broken stem. Cement was

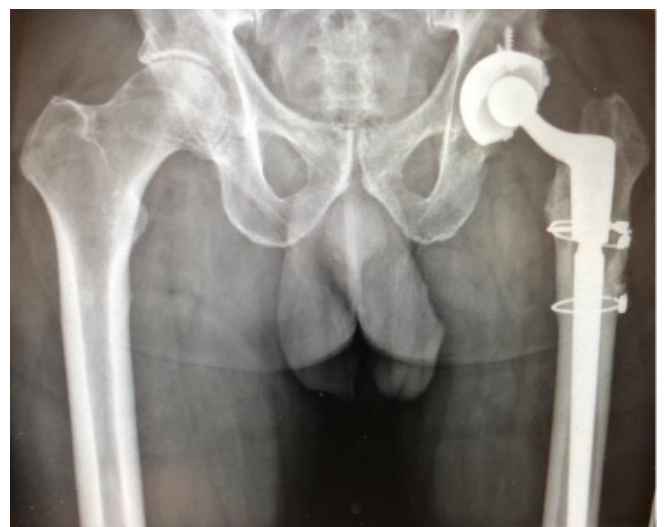
Figure 6. — Anteroposterior view after re-revision with an uncemented modular stem (Restoration)(2022).

taking out using distal and cement reamers, retrograde hooks and the Oscar bone cement removal system. Reimplantation was performed with the Restoration stem ((Stryker, Kalamazoo, Michigan, United States of America) aiming for distal fit (Figure 6 & 7).

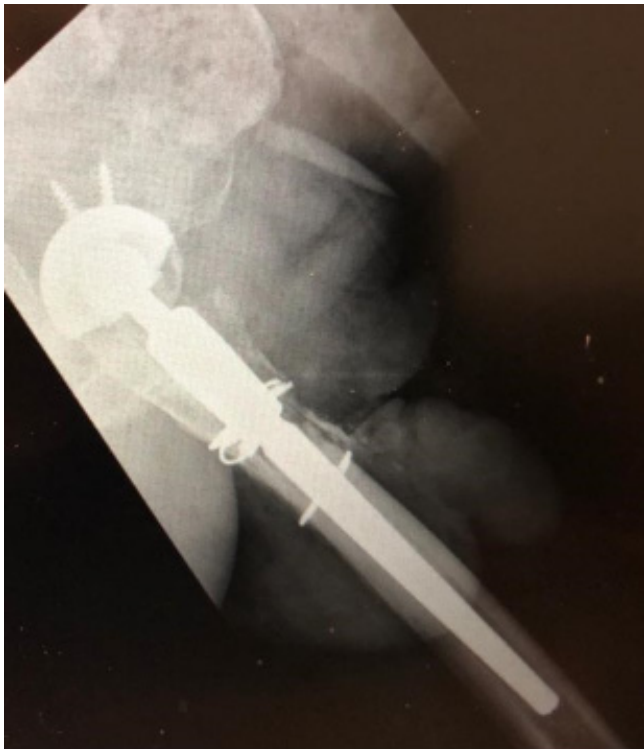
Figure 7. — Lateral view after re-revision of the stem (2022).
