Internal fixation of a traumatic fracture around a hip resurfacing arthroplasty using the proximal femoral locking compression plate

Axel J. WEUSTEN, Sameer K. KHAN, Sandra J. BONCZEK, Deena ELSHARIEF, Ian W. WALLACE

From James Cook University Hospital, Middlesbrough TS4 3TG, U.K.

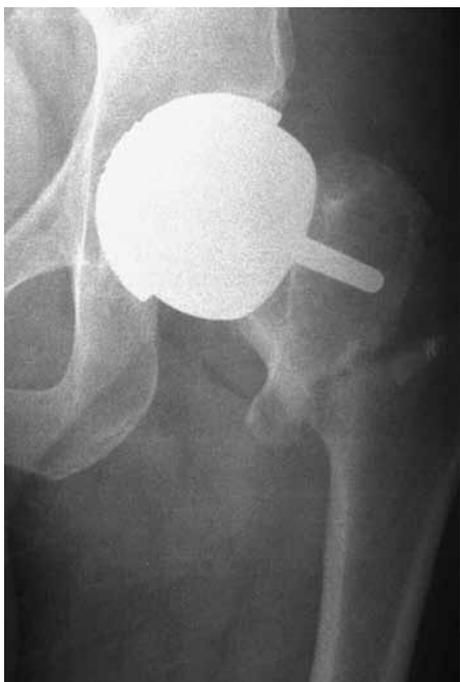
Fig. 1. — AP radiograph showing type and extent of fracture in the left proximal femur.

fracture. The hip fracture was intertrochanteric (OTA type 31-A2.2) with metaphyseal fragmentation and a minor subtrochanteric extension (16). The patient was keen on retaining his resurfacing prosthesis and elected to be repatriated back to the UK. The receiving surgical team also felt that conversion to a total hip arthroplasty was not feasible given the subtrochanteric extension of the fracture (Fig. 1).

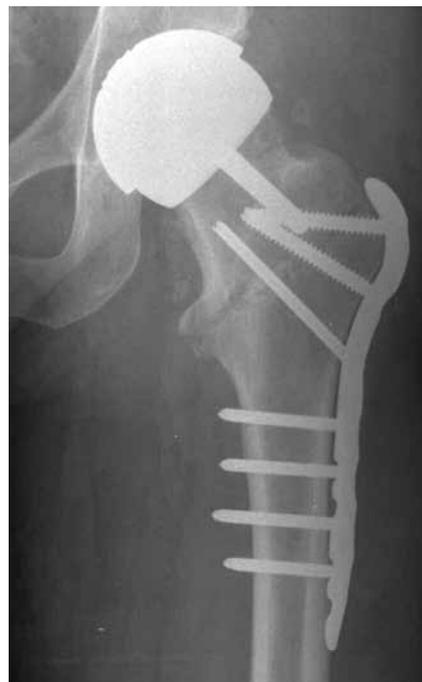
Fig. 2. — Immediate post-op AP radiograph showing the mode of fixation of the fracture.

The patient was positioned on the traction table and the fracture was reduced closed with minor valgus angulation. A 4.5 mm proximal femoral locking compression plate (LCP, Synthes®, Welwyn Garden City, UK) was used to stabilise the fracture, with three cannulated locking screws (two 7.3 mm and one 5 mm) through the proximal portion of the plate. Care was taken to position the screws in the femoral neck away from the resurfacing stem (Fig. 2). The ankle fracture was stabilised in the same setting using standard osteosynthesis technique. Postoperative management included bed rest for 6 weeks with active and passive exercises to increase range of motion, followed by 6 weeks of

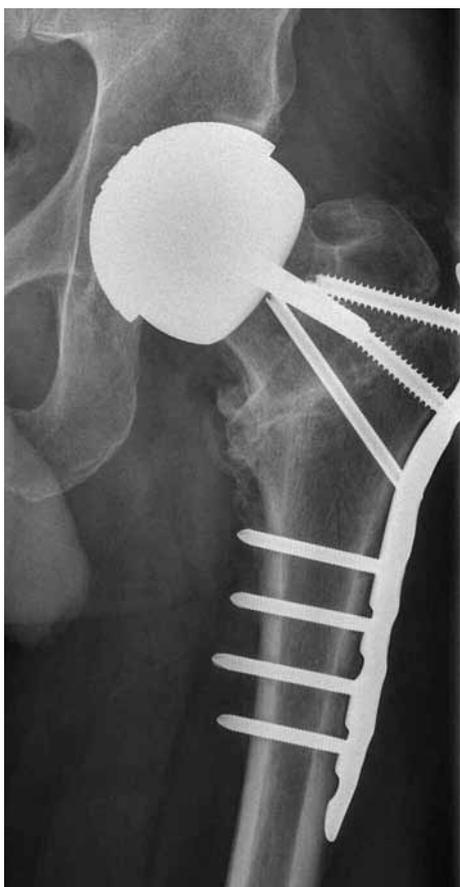
Fig. 3. — AP radiograph at 12 weeks

partial weight bearing on crutches. At 18 weeks following surgery, the patient had regained a pain-free and full range of movement. He was bearing his weight fully through the operated leg. His Harris Hip Score at the last appointment was 100. Radiographs confirmed fracture union (Fig. 3).
